TOP NOTCH HOME INSPECTIONS

## RESIDENTIAL PROPERTY INSPECTION

1234 Main Street  
Bay Roberts, NL A0A 1G0

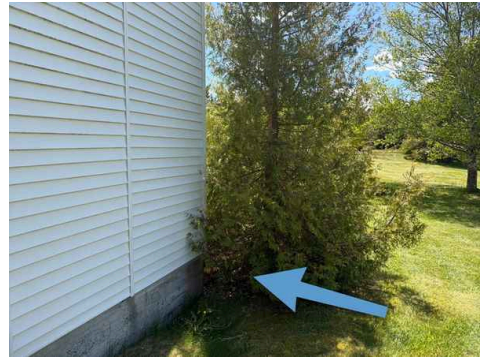
## 3.3.2 Vegetation Observations

**TREE CLOSE TO FOUNDATION**

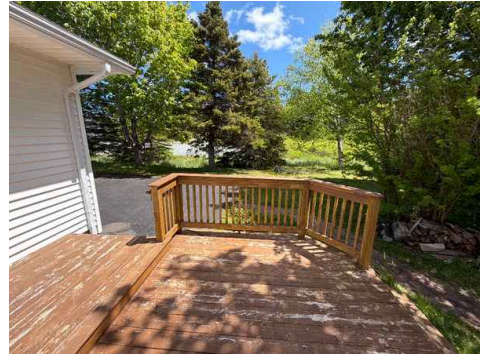
## 3.6.1 Stairs, Steps, &amp; Ramps

**UNEVEN STAIR RISER HEIGHT**

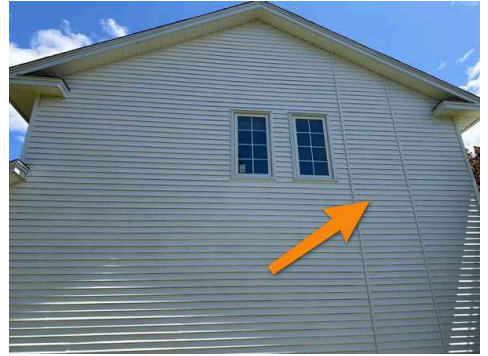
## 4.3.2 Vinyl Siding

**VINYL SIDING - DAMAGE**

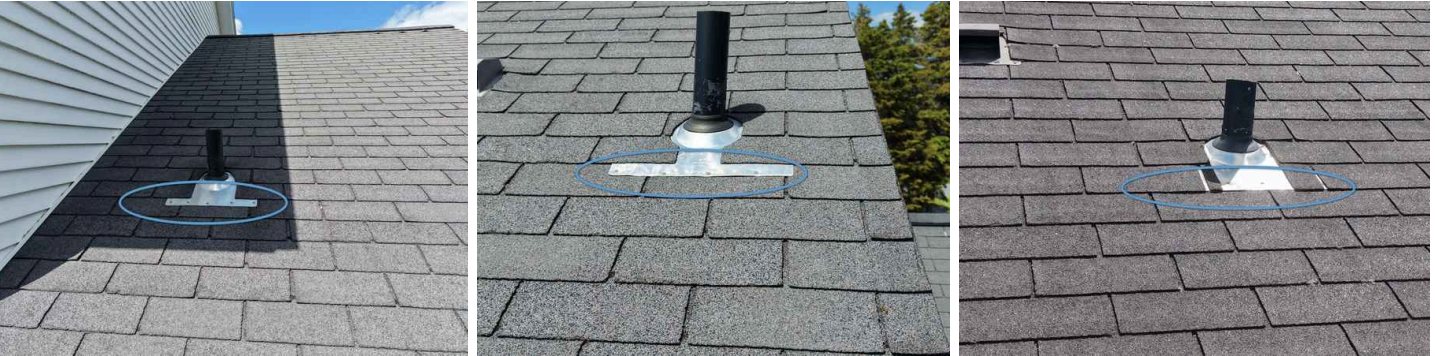
## 5.4.2 Vents/Roof Protrusions

**SERVICE MAST BOOT - DAMAGED**

Contact a qualified roofing professional.

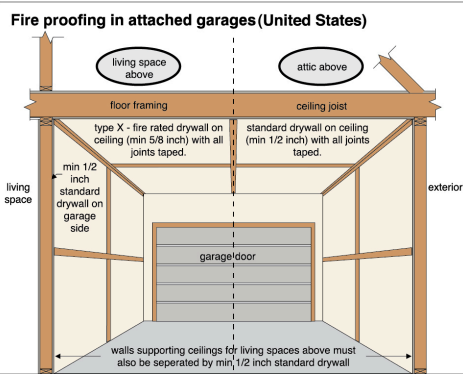
6.6.3 Garage Separation

CEILING SEPARATION - COMPROMISED  
(ATTIC ACCESS)

Recommendation  
Contact a qualified professional.

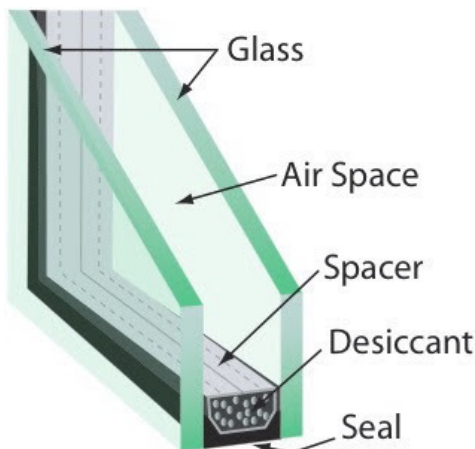
9.3.6 Windows

**HARDWARE - DAMAGED WINDOW CRANKS**

Contact a qualified professional.

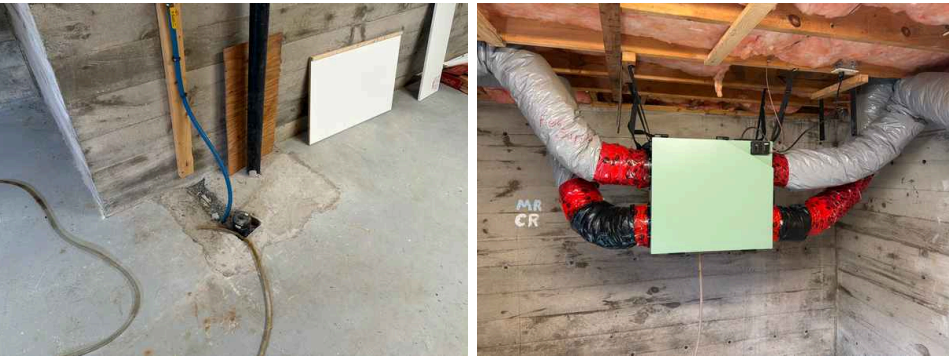
The HRV condensate drain hose is not connected to a floor drain or proper water dispersal system. Instead, it sits on the slab near the main cleanout, allowing condensate to soak into the ground beneath the slab. This can lead to moisture accumulation under the foundation, potentially causing structural damage, mold growth, and compromised foundation integrity. The drain hose should be properly connected to an approved drainage system / device. It is recommend for customer to have HRV installer or plumber evaluate for best solutions pertaining to this install location.

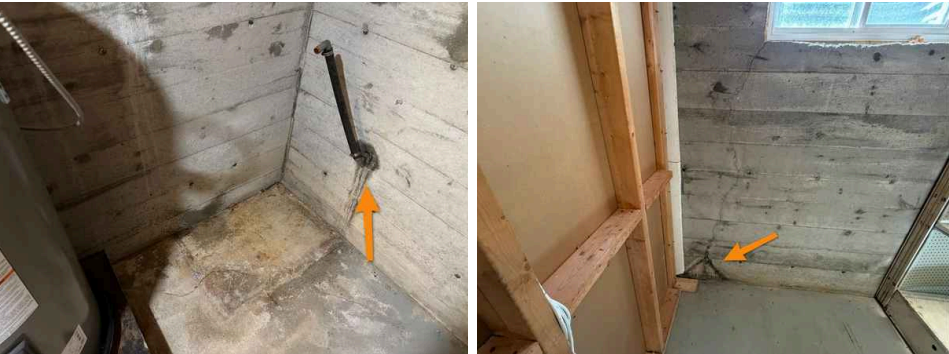
The foundation wall displays evidence of previous moisture intrusion. Water penetration into foundation walls can lead to structural deterioration, mold growth, and compromised foundation integrity if not properly addressed. A foundation contractor should evaluate the extent of moisture damage and recommend appropriate waterproofing or remediation measures.

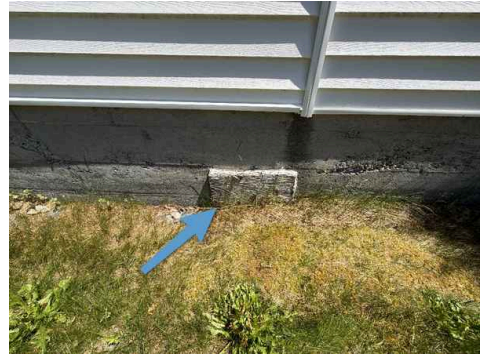
A section of the foundation wall has a small opening that is currently covered with a piece of plywood. The purpose and nature of this opening cannot be determined from external observation alone. Contact the seller to clarify what this opening is for, whether it serves a functional purpose (such as ventilation, drainage, or utility access), and how long it has been covered.
