TOP NOTCH HOME INSPECTIONS

## RESIDENTIAL PROPERTY INSPECTION

1234 Main Street  
Bay Roberts, NL A0A 1G0

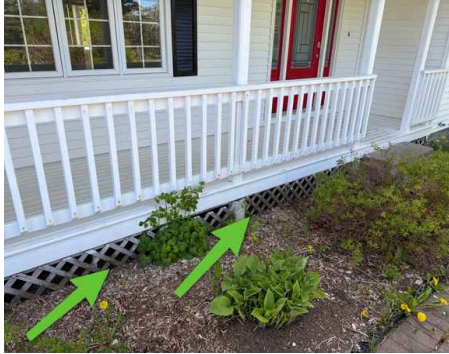
### Porch(es), Patio(s), & Flatwork: Structural Assembly Not Visible - Wooden Porch

**LMT** - The structural assembly for the wooden porch was not visible due to the porch's proximity to the ground and/or being enclosed underneath. The framing for this porch is excluded from this inspection.

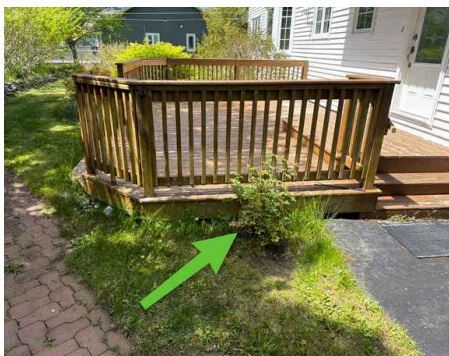
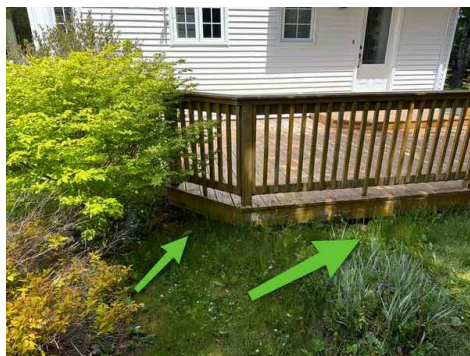
### Decks: Structural Assembly - Not Visible (Covered)

**EXCL** - The structural assembly for the referenced deck was not visually accessible due to the framing being covered. The condition of the framing is excluded from this inspection.

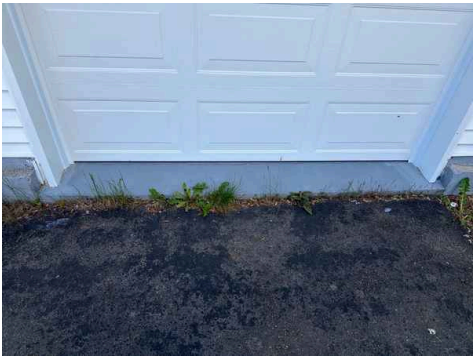
**SFTY** - Cracking, heaving, settlement, movement, deterioration, and/or other defects resulting in trip hazards were present on the referenced surface(s). Repairs are recommended to be conducted to these area(s) as needed for safety by a qualified contractor.

Recommendation  
Contact a qualified professional.

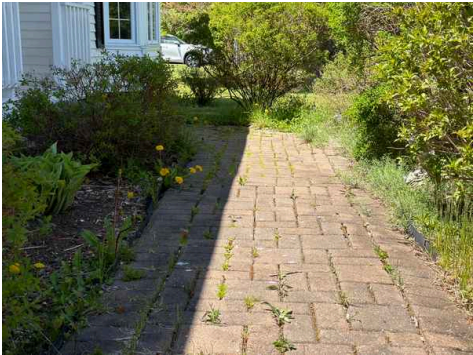
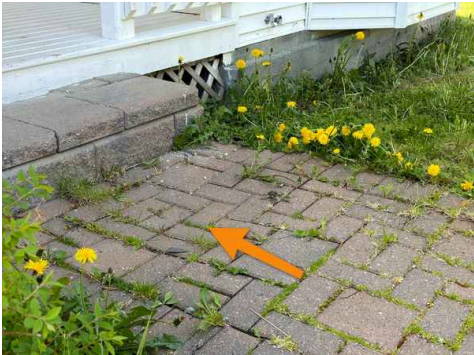
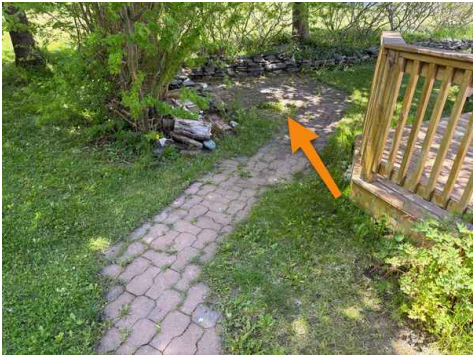
3.1.2 Driveway and Walkway Condition

Brick pavers in the driveway and walkway are uneven, creating an irregular surface. This unevenness can create tripping hazards for pedestrians and may allow water to pool in low areas, potentially causing drainage issues and accelerated deterioration. A masonry contractor should evaluate the pavers and reset or replace them as needed to restore a level, safe surface.

Recommendation  
Contact a qualified professional.

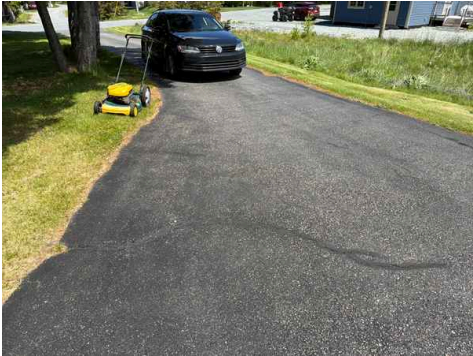
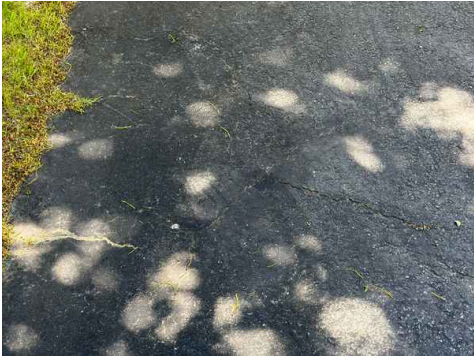
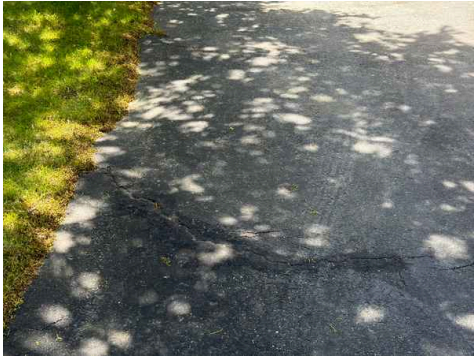
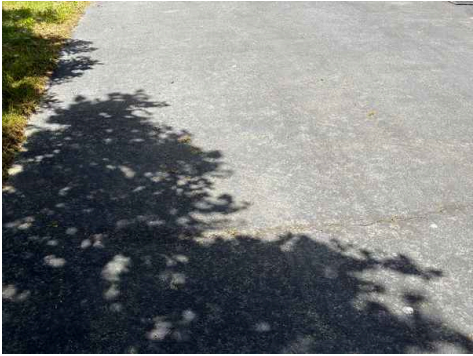
3.1.3 Driveway and Walkway Condition

- ⊖ 3.1.3 Grounds & Appurtenances - Driveway and Walkway Condition: Minor Driveway Cracking
- ⊖ 3.2.1 Grounds & Appurtenances - Grading/Lot Drainage: Grading - Inadequate/Improper Slope

Recommendation

Contact a qualified professional.

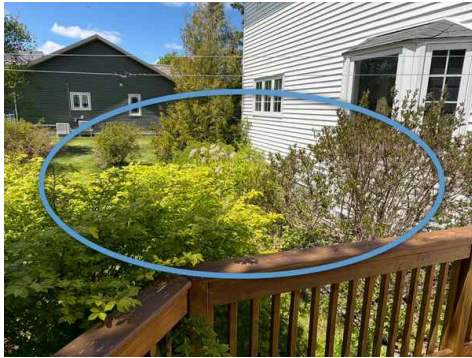
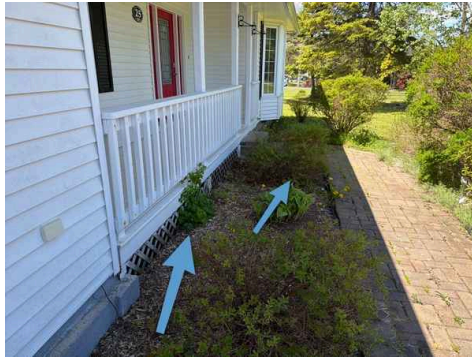
### 3.2.2 Grading/Lot Drainage

- 🔧 3.2.2 Grounds & Appurtenances - Grading/Lot Drainage: Hard Grade - Improper/Inadequate Slope
- 🔧 3.3.1 Grounds & Appurtenances - Vegetation Observations: Vegetation - Against/Near the Structure

## Recommendation

Contact a qualified landscaping contractor

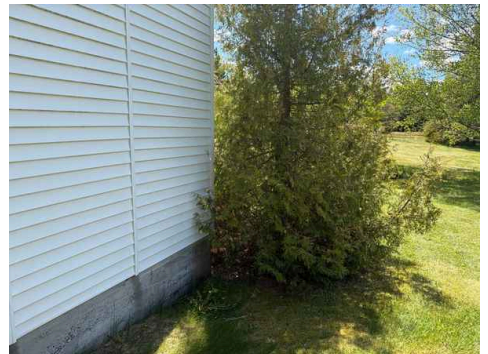
## 3.3.2 Vegetation Observations

**TREE CLOSE TO FOUNDATION**

Moderate Concerns

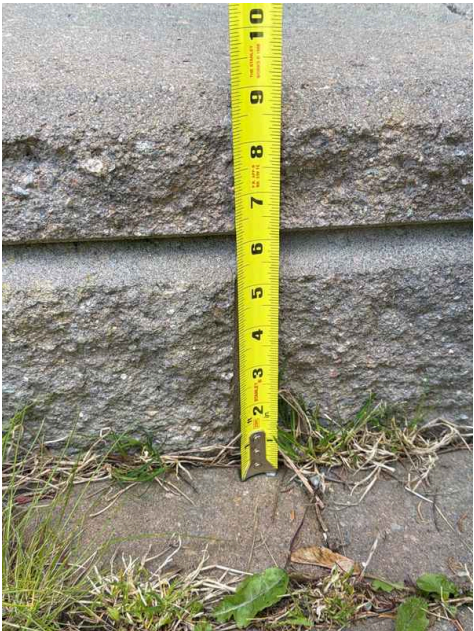
3.4.1 Porch(es), Patio(s), & Flatwork

- ⊖ 3.3.2 Grounds & Appurtenances - Vegetation Observations: Tree Close to Foundation
- ⊖ 3.4.1 Grounds & Appurtenances - Porch(es), Patio(s), & Flatwork: Step up greater than 7 3/4

Recommendation

Contact a qualified professional.

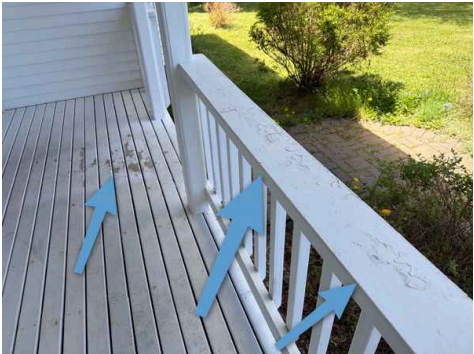
3.4.2 Porch(es),  
Patio(s), & Flatwork

- 🔧 3.4.2 Grounds & Appurtenances - Porch(es), Patio(s), & Flatwork: Wood - Maintenance Needed
- 🔧 3.5.1 Grounds & Appurtenances - Decks: Wood - Neglected (Maintenance/Repairs Recommended)

Recommendation

Contact a qualified professional.

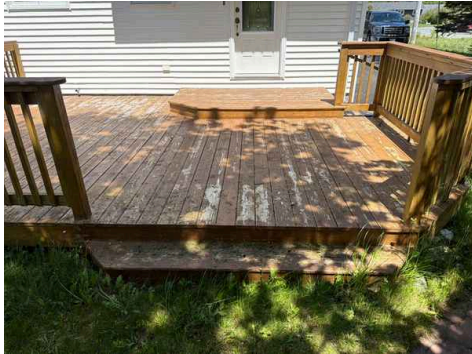
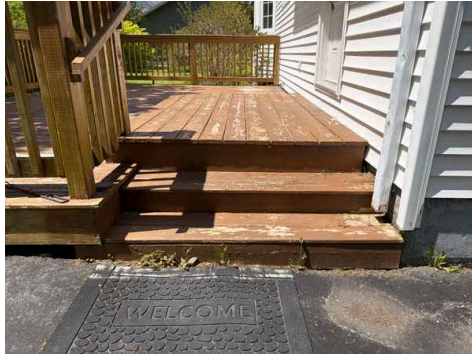
## 3.5.1 Decks

**WOOD - NEGLECTED  
(MAINTENANCE/REPAIRS RECOMMENDED)**

## Recommendation

Contact a qualified deck contractor.

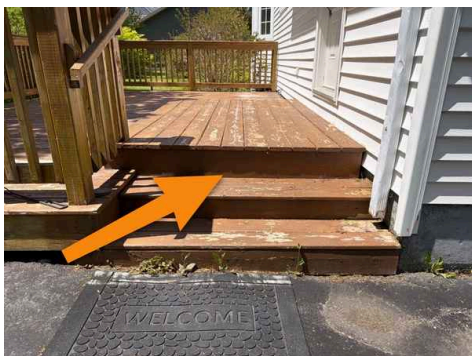
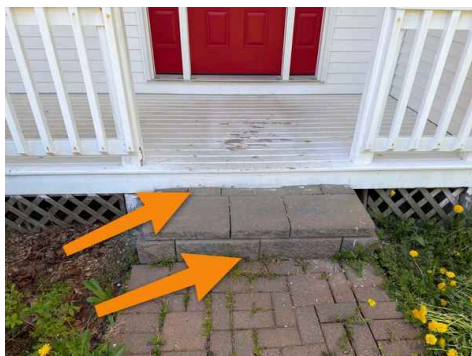
## 3.6.1 Stairs, Steps, &amp; Ramps

**UNEVEN STAIR RISER HEIGHT**

## Recommendation

Contact a qualified professional.

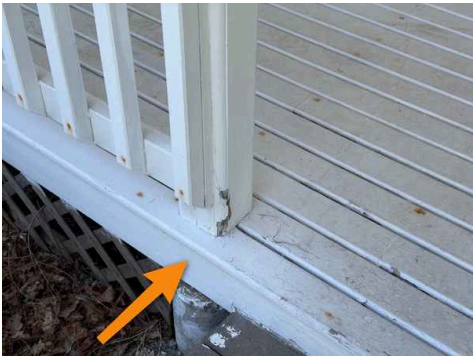
3.8.1 Appurtenance Roof Condition

SUPPORT POST(S) - WATER DAMAGE

Some degree of water damage was observed at the base of the roof support post(s). Prolonged moisture exposure can lead to wood decay or structural weakening if left unaddressed. Repairs to correct the damage and help prevent further deterioration are recommended to be performed as needed by a qualified contractor.

Recommendation  
Contact a qualified professional.

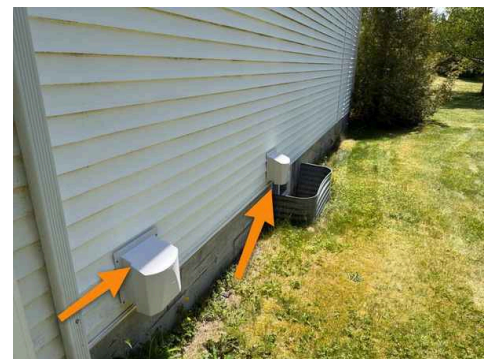
### 4.2.1 Walls/Cladding

#### MISSING CAULK ON VENT PROTRUSIONS

Proper caulking or sealant is not visible on top of vent protrusions on the exterior wall. Without adequate sealing, water can penetrate behind the vent flashing and enter the wall cavity, potentially causing water damage, rot, and mold growth. Have a qualified professional inspect the vent installations and apply appropriate weatherproof caulk or sealant to all exposed seams and joints.

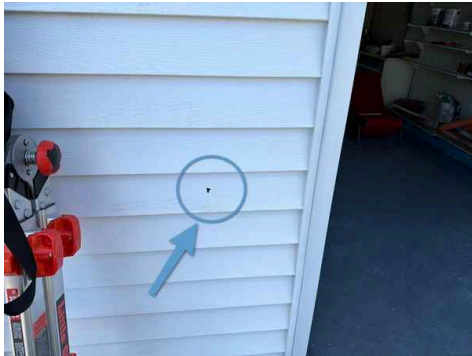
left of garage door

**VINYL SIDING - DAMAGE**

There was damage present at areas of the vinyl siding, which can include holes, cracks, and/or similar defects. Damaged siding can allow for moisture intrusion, pest entry, or deterioration of underlying materials. Repairs or replacement of the damaged siding is recommended to be performed as needed by an exterior contractor or other qualified professional.

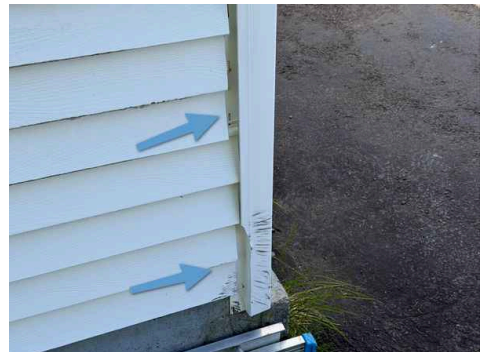
## 4.3.3 Vinyl Siding

**CORNER TRIM - DAMAGE**

Vinyl corner trim was present that was damaged at the referenced area(s). Repairs or replacement as needed to prevent moisture infiltration is recommended to be performed by a qualified contractor.

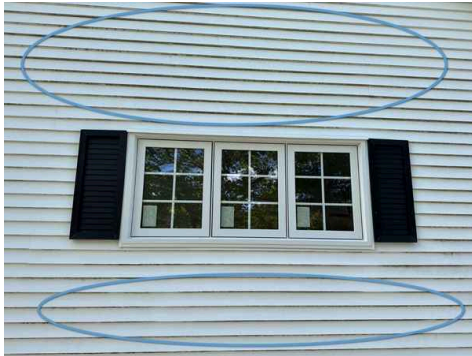
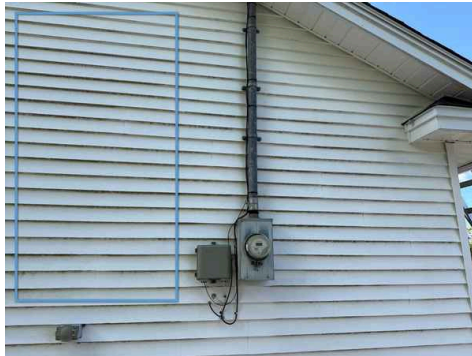
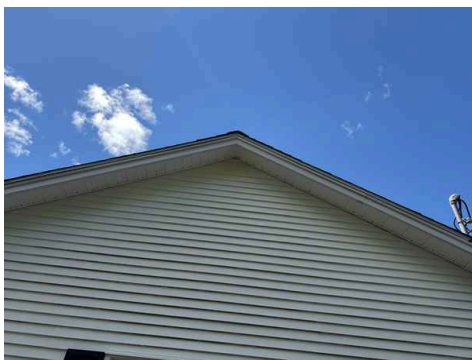
## 4.3.4 Vinyl Siding

**MILDEW ON VINYL SIDING**

Mildew-like substance observed on vinyl siding in multiple areas during inspection. This cosmetic issue can be cleaned but may indicate moisture retention or poor drainage in those areas. Cleaning is recommended to restore appearance and prevent further growth. Monitor for future occurrence / maintenance requirements.

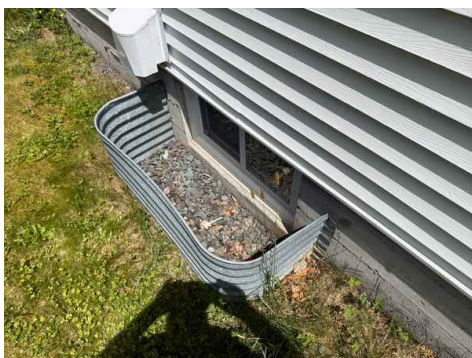
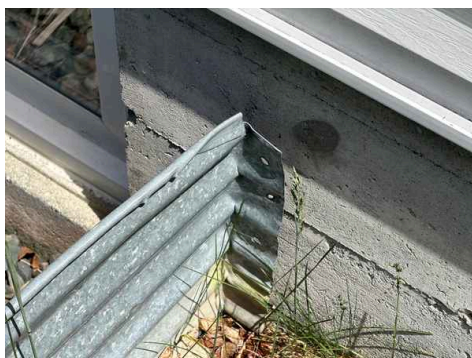
## 4.4.1 Window Exteriors

**WINDOW WELL(S) - MOVEMENT (PULLED AWAY)**

Corrugated galvanized metal window well observed at basement window. The well appears detached/loose and is not properly attached to the foundation. This condition may allow movement, soil intrusion, or water entry; recommend qualified repair.

Contact a qualified professional.

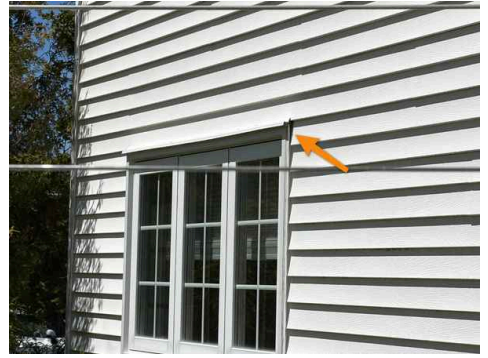
## 4.4.2 Window Exteriors

**IMPROPER WINDOW DRIP CAP INSTALLATION**

Drip caps seem to not be installed on top of windows properly. It may be positioned or secured incorrectly. This can allow water to penetrate behind the cap and into the wall cavity, potentially causing water damage, rot, and structural issues over time. This could be a point of water intrusion.

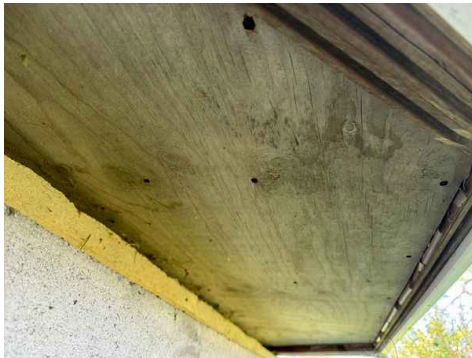
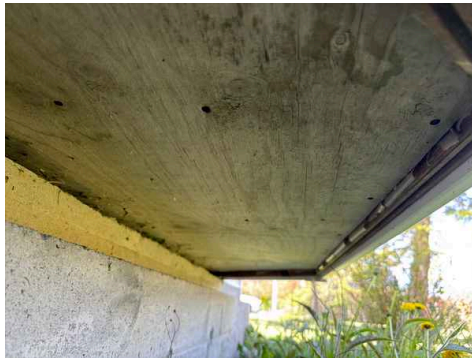
## 4.4.3 Window Exteriors

**EXPOSED PLYWOOD AT BAY WINDOW**

Exposed plywood was observed beneath the bay window on the exterior wall. Exterior bay-window undersides are normally finished with a weather-resistant covering or soffit-style material, because that area still sees wind-driven rain, splashback, and moisture exposure. Unprotected plywood will absorb moisture, leading to rot, structural deterioration, and potential water infiltration into the wall cavity. A vinyl siding contractor should evaluate and install cladding or trim to restore weather protection.

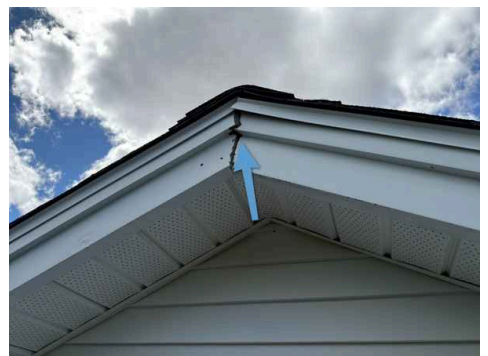
## 4.6.1

There were gaps present on the fascia wrap at some transitions. Sealing these areas or repairs made as needed to prevent moisture infiltration is recommended to be performed by a qualified person.

Contact a qualified professional.

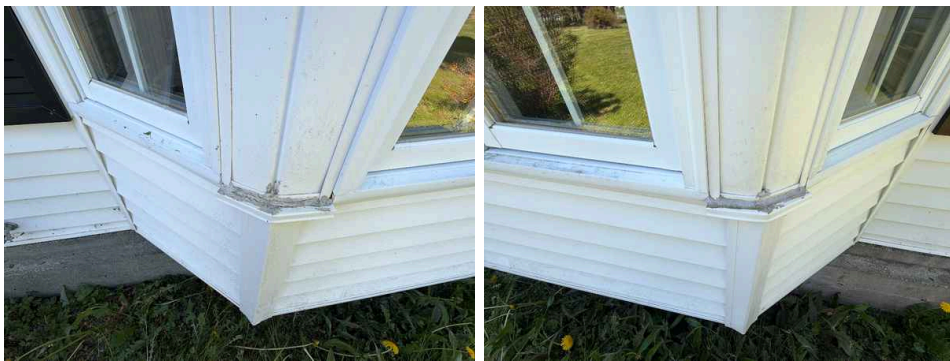
There were area(s) in need of sealant to prevent moisture and/or insect infiltration. The application of sealant at any gaps into the wall cavity is recommended to be performed by a qualified person.

There was sealant present that was in need of maintenance/re-application at the referenced area(s). Properly sealing these areas is recommended to be performed by a qualified person to prevent moisture infiltration.

Contact a handyman or DIY project

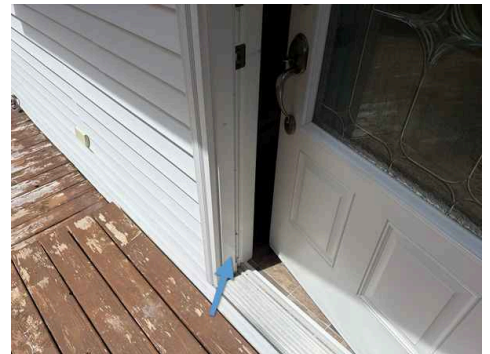
4.8.1 Exterior  
Doors

**WEATHER SEAL DAMAGE ON EXTERIOR DOOR**

The weather seal around the exterior door is damaged, compromising the door's ability to create a weathertight seal. This allows air infiltration, moisture entry, and potential water damage around the door frame. The damaged seal should be replaced or repaired by a qualified door professional to restore proper weatherproofing and energy efficiency.

Recommended DIY Project

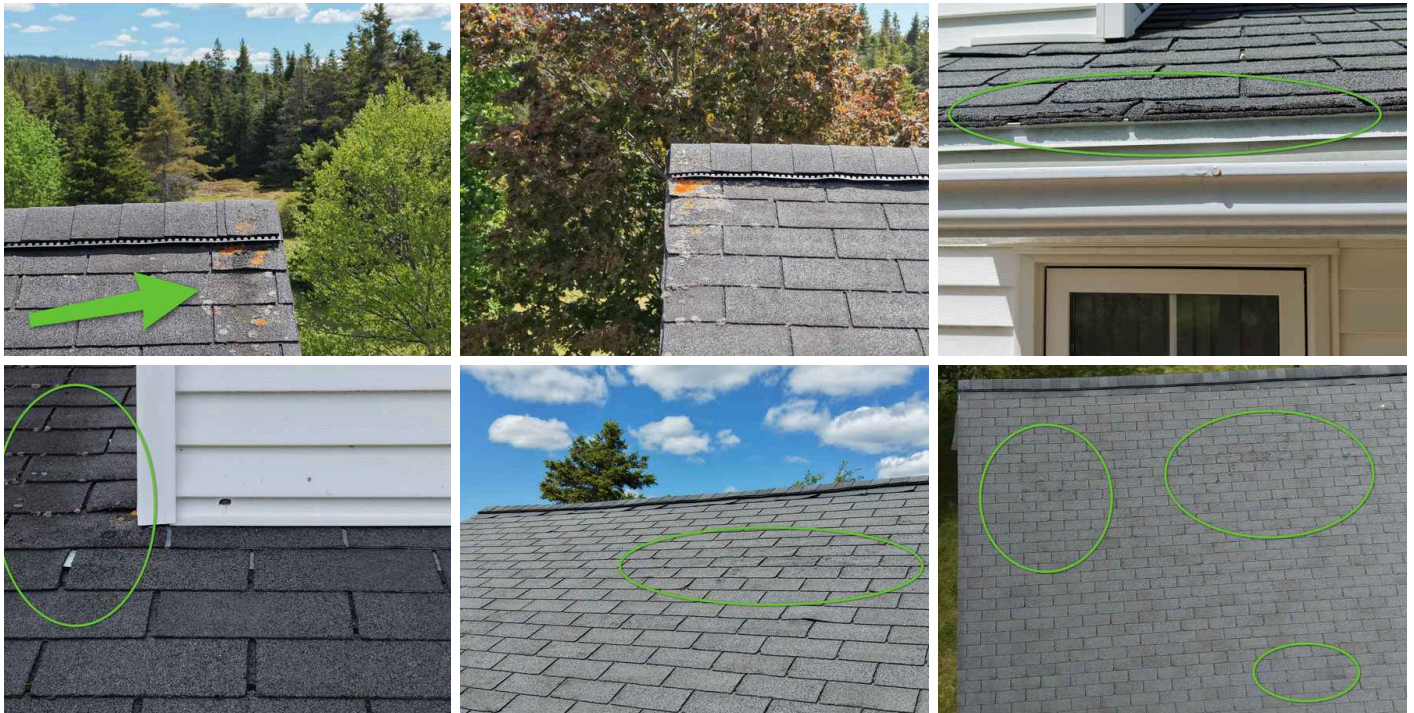
### Shingles: Shingles - Granule Loss in Areas (Typical Aging)

The shingles had granule loss in areas, this is a typical part of the aging process, and an indicator that the shingles are in the last third of their life. Recommend a roofer evaluate and recommend a timeline for budgeting toward future replacement.

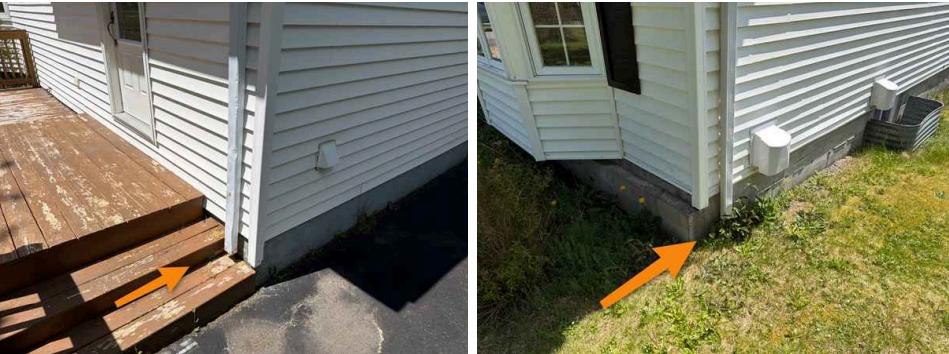
5.6.4 Gutters/Downspouts

DOWNSPOUT(S) - NOT PRESENT

No downspouts were present for the gutter, allowing the gutters to discharge water within 5 feet of the structure. Current standards require downspouts to be diverted at least five feet from the foundation of the home to prevent the grounds surrounding the foundation from becoming saturated. Saturated grounds can allow water / moisture to enter basement and crawl space areas, and in extreme cases can allow for settlement of the home. The installation of downspouts that divert water at least five feet away from the home is recommended by a gutter contractor.

Recommendation  
Contact a qualified professional.

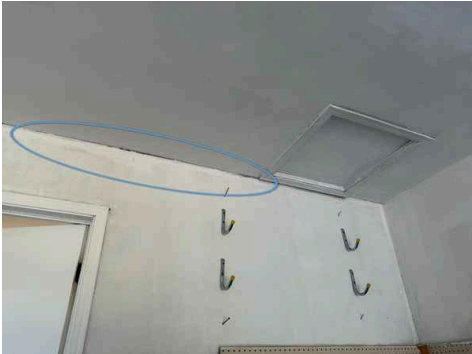
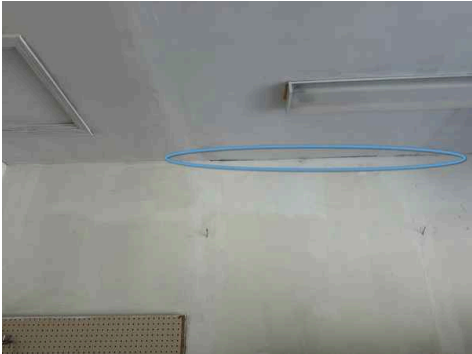
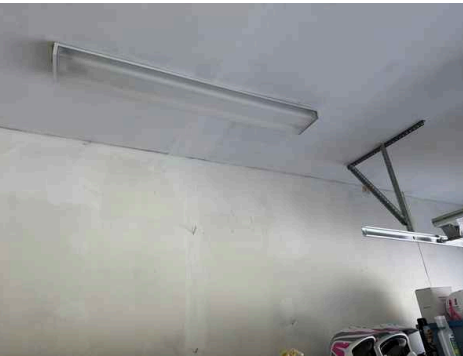
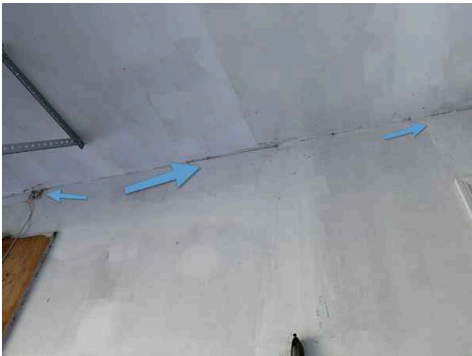
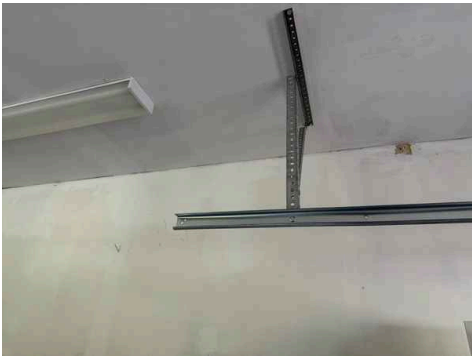
6.6.2 Garage Separation

**SFTY** - The ceiling in the garage was "unfinished," finished with an improper material, had gaps present in the drywall, or contained other deficiencies that prevented proper separation. Although this may have been acceptable when the home was built, current standards require the installation of 1/2" to 5/8" Type X drywall on the ceiling to provide proper separation of the garage to living area space (situational), with no holes or gaps allowed in the ceiling without being sealed with an approved material. The installation of proper drywall or repairs made as needed to achieve proper separation is recommended to be conducted by a qualified contractor as a safety upgrade. The pictures show provide a sample only.

Recommendation  
Contact a qualified professional.

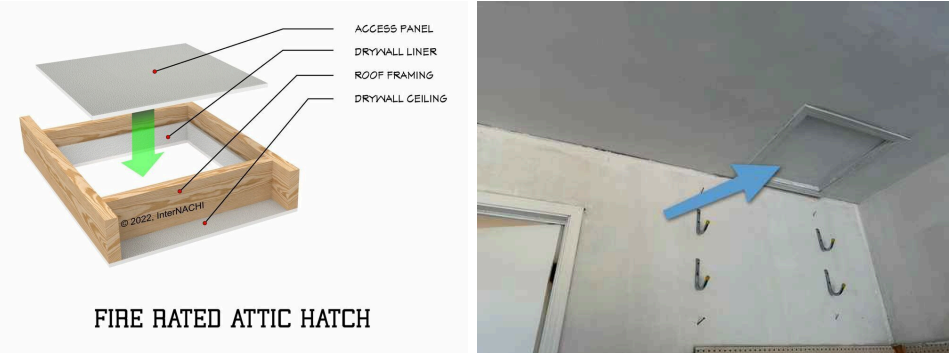
6.6.3 Garage Separation

CEILING SEPARATION - COMPROMISED  
(ATTIC ACCESS)

**SFTY** - The garage-to-living space separation was compromised due to a non-drywall material or a non-fire-rated attic access panel being located in the garage ceiling. Current standards require garage ceilings to be covered with 1/2" drywall when no living space is overhead, or the walls between the living areas and garage would need to extend up through the attic to the underside of the roof structure (covered by 1/2" drywall). An evaluation of the attic access with repairs or modifications made as needed to achieve proper garage to dwelling space separation is recommended to be performed by a qualified professional.

Recommendation  
Contact a qualified professional.

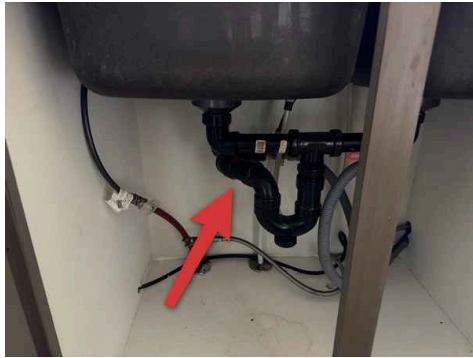
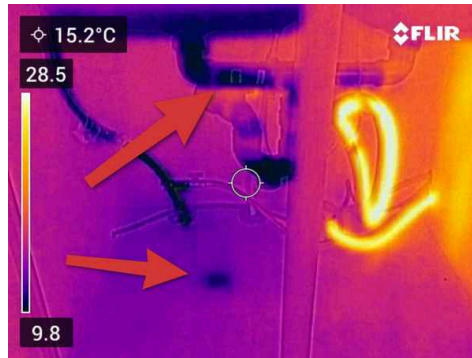
Kitchen

**UNDER SINK PLUMBING LEAK**

Significant Defects

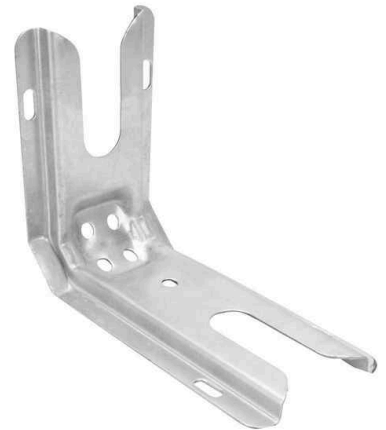
**SFTY** - An anti-tip bracket was either not installed for the range or was not functioning to prevent tipping. An anti-tip bracket is designed to prevent the range from tipping over if weight is applied to the open oven door, such as a child stepping or sitting on it. Ranges typically contain a warning label inside the oven door with additional information. Anti-tip brackets are available at home improvement stores. Installation of an anti-tip bracket is recommended to be performed by a qualified person for safety.

Moderate Concerns

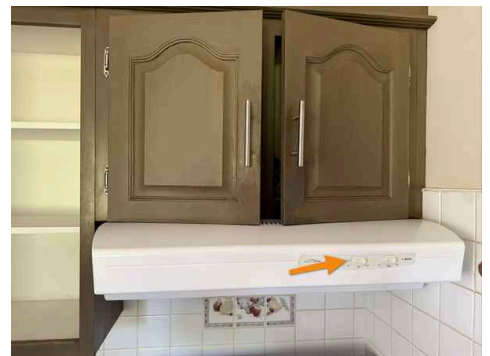
**FAN - NOT FUNCTIONING PROPERLY**

The exhaust fan did not operate on low. Evaluation and repairs or replacement as needed is recommended by a qualified person for proper operation.

Moderate Concerns

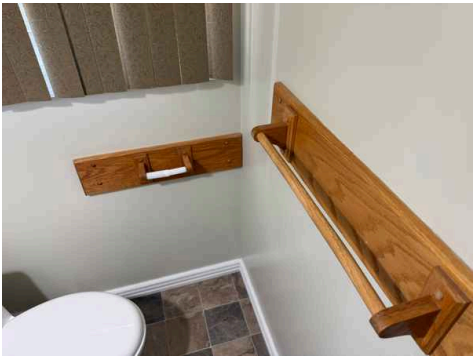
**LOOSE TOWEL RACKS**

Towel racks are loose on the wall. This indicates fasteners have loosened or wall anchors have failed, creating a potential hazard if the racks fall. Tighten all mounting bolts and inspect wall anchors for damage; replace anchors if necessary.

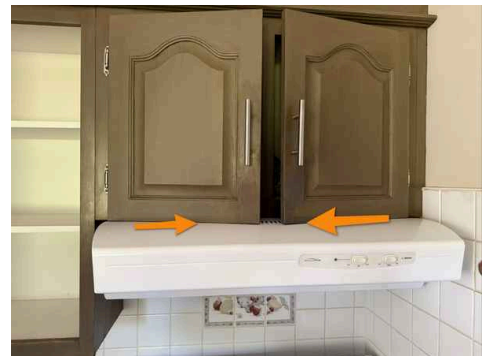
There were cabinet doors/drawers that were in need of "detailing." Detailing can include replacement of hardware, adjustments, and/or other minor repairs to allow the doors/drawers to latch and operate smoothly. Repairs are recommended to be performed as needed for proper operation by a qualified person.

Moderate Concerns

Doors rubbing on top of range hood fan

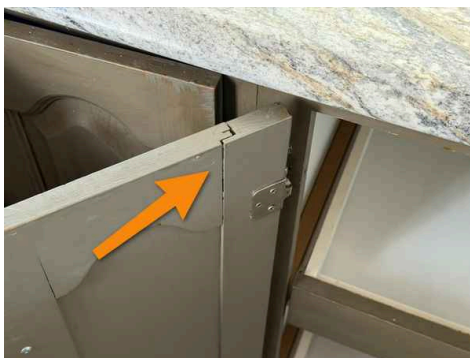
Peninsula

**CABINETRY - DAMAGED**

The cabinetry was damaged in the referenced area(s). Damaged cabinetry can reduce functionality and appearance, and in some cases may allow for further deterioration if not corrected. Repairs or replacement of the damaged areas is recommended to be performed by a qualified person.

Moderate Concerns

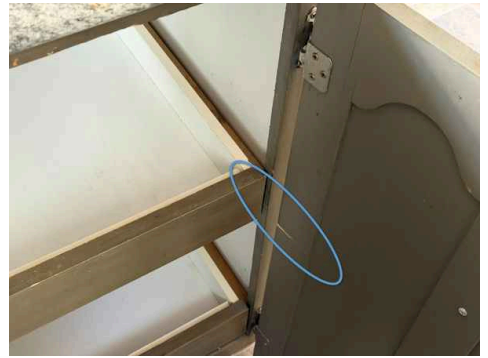
There were cabinet drawer(s) present that were not functioning properly. They were rubbing against the cabinet door. Repairs are recommended here as needed for proper operation by a qualified person.

Contact a qualified professional.

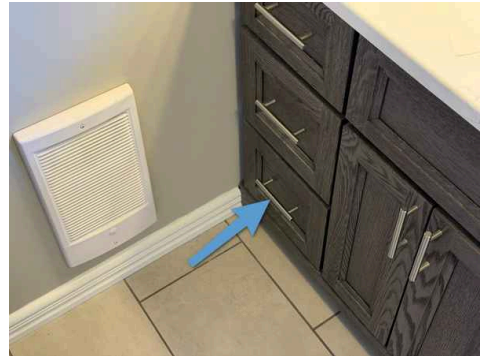
The false drawer was sealed in place. If a concern repairs are recommended as needed by a qualified person.

Contact a qualified professional.

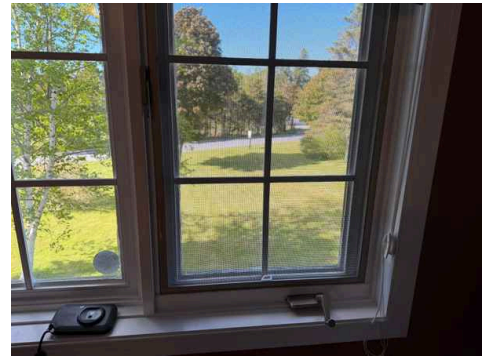
Front right bedroom

**WINDOWS - AGED WITH MULTIPLE DEFECTS**

**AGED** - There were multiple defects present with window(s) throughout the structure. Most of the windows in the home were replaced. **The windows of concern here are all the original windows on the front of the home.** Conditions observed may include, but are not limited to, hindered operation, damaged or missing hardware, and glass-related issues such as cracked panes or failed seals. A full evaluation of all windows is recommended to be performed by a qualified window contractor, with repairs or replacement made as needed to ensure proper operation, safety, and energy efficiency.

Contact a qualified window repair/installation contractor.

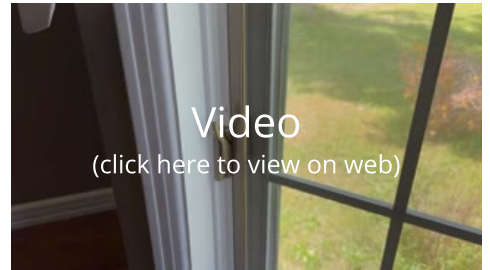
Front Living Room

Moderate Concerns

The window(s) in the referenced area(s) were difficult to latch at the time of inspection. Improperly functioning latches can affect security, energy efficiency, and weather resistance. Repairs to restore proper latch operation are recommended to be performed by a window contractor or other qualified person.

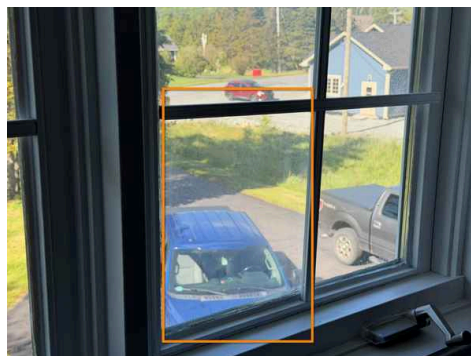
**GLASS - SEAL FAILURE**

Contact a qualified window repair/installation contractor.

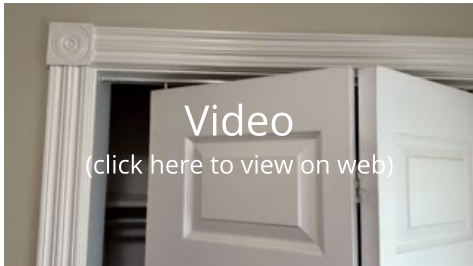
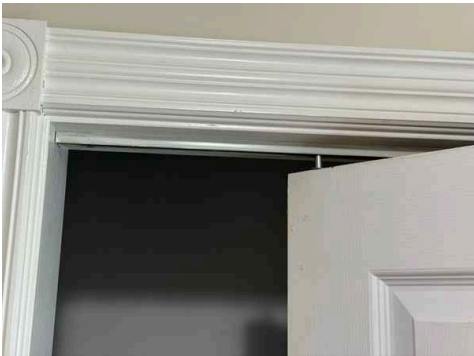
Front Foyer

FRONT ENTRY FOYER

The sliding hardware on the closet door is loose, which was observed during inspection. Loose hardware can cause the door to bind, derail, or fail to operate smoothly, creating difficulty accessing closet contents. Tighten all mounting bolts and brackets securing the sliding track system to ensure proper alignment and smooth operation.

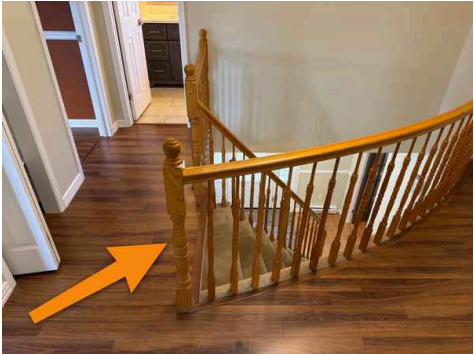
**SFTY** - The handrail/stair guard was loose at the time of inspection. A loose handrail can pose a safety hazard by reducing support and stability for users when ascending or descending stairs. Repairs to properly secure the handrail to the wall are recommended to be performed by a qualified person to ensure safe and reliable use.

Recommendation  
Contact a qualified professional.

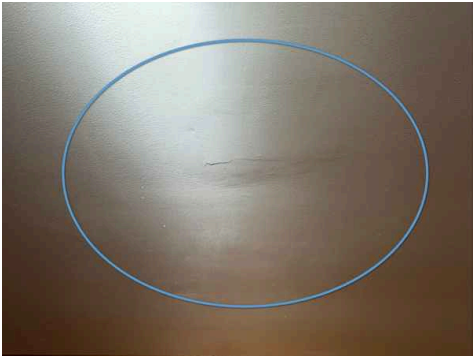
Front left bedroom

Patched or repaired area(s) were present on the ceiling(s) in the referenced area(s). I recommend consulting with the seller(s) as to why the patching was conducted along with obtaining any applicable invoices or records of the repairs (if applicable).

Recommendation  
Contact the seller for more info

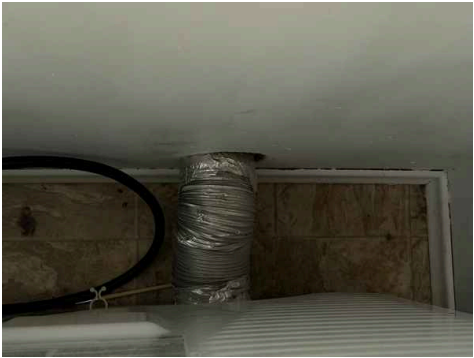
The dryer vent duct was constructed of flexible material. Current standards recommend dryer exhaust ducts be constructed of rigid metal with a smooth interior finish and a minimum thickness of 0.016 inch (0.4 mm). Flexible ducts are more prone to lint accumulation, restricted airflow, and fire hazards. Replacement of the vent with proper materials is recommended to be performed by a qualified person.

Recommendation  
Contact a qualified professional.

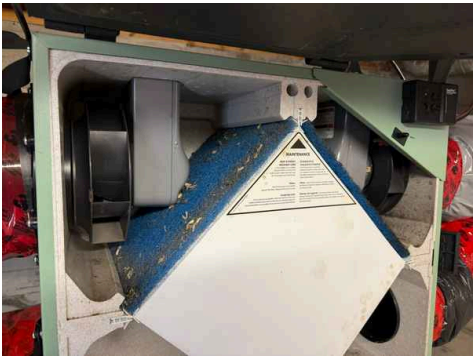
There were dirty or missing filter(s) at the HRV/ERV unit. Dirty or missing filters can reduce airflow, decrease efficiency, and place additional strain on the system. Replacement or cleaning of the filter(s), as recommended by the manufacturer, is recommended.

Recommendation  
Recommended DIY Project

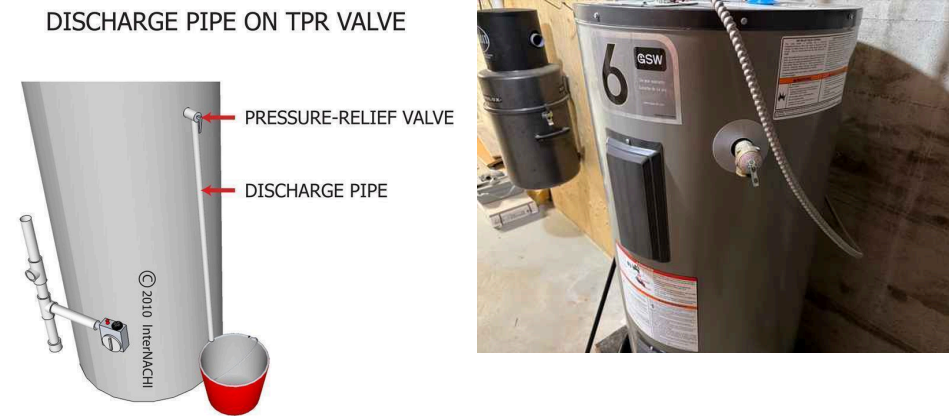
TPRV PIPE - MISSING

**SFTY** - A discharge pipe was not present at the water heater's temperature and pressure relief (TPR) valve at the time of inspection. A properly installed discharge pipe, made of copper, CPVC, or PEX with a ¾-inch interior diameter (I.D.), should be connected to the TPR valve and terminate no more than 6 inches above the floor. Without a discharge pipe, there is a risk of scalding or water damage in the event of valve activation. Installation of a proper TPR valve discharge pipe is recommended to be performed by a licensed plumber or other qualified person.

Recommendation  
Contact a qualified plumbing contractor.

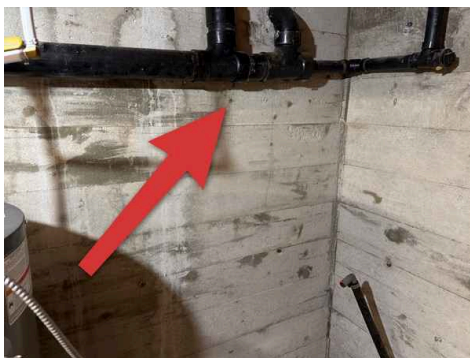
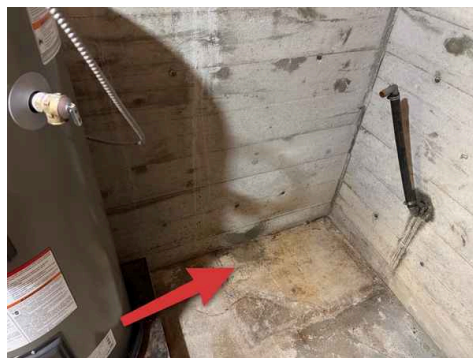
There were active leaks observed at the drain, waste, and vent piping in the referenced area(s). Active leakage can contribute to moisture damage, microbial growth, and deterioration of nearby materials if not corrected.

An evaluation of the drain, waste, and vent system is recommended to be performed by a licensed plumbing contractor, with repairs made as needed to eliminate any active leaks.

Contact a qualified plumbing contractor.

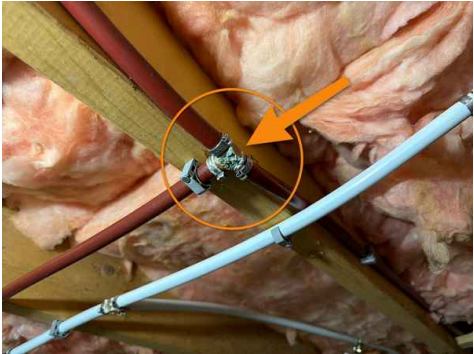
Area(s) of corrosion were present on portions of the water distribution pipes and/or fittings. Corrosion is a sign of a past or present leak and can allow for failure. An evaluation and replacement of affected portions is recommended to be performed by a licensed plumbing contractor.

Recommendation  
Contact a qualified plumbing contractor.

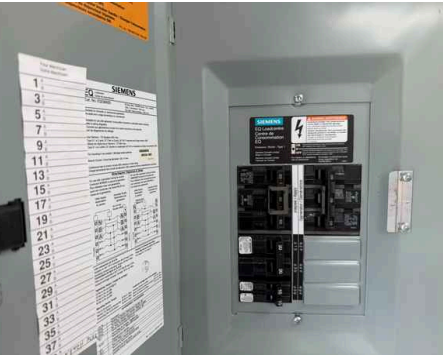
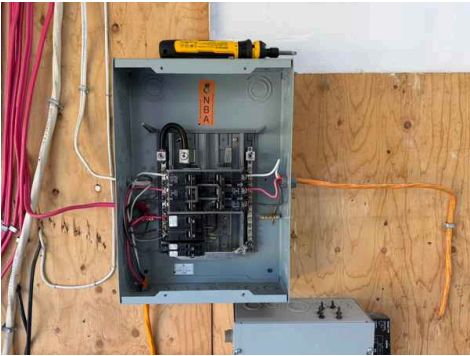
The subpanel / load center seems to be wired for the purposes of a generator according to the label. **NOTE: I am not 100% sure that this wired to current safety specifications for the given setup. I recommend an electrician do a quick review to double check.**

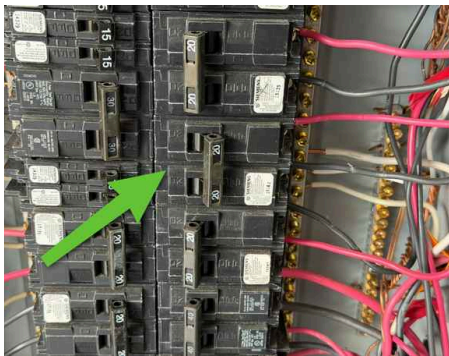
**LMT** - There were breaker(s) present that were in the "off" position at the time of inspection. These breakers were not turned on to test for functionality of components they may power. I recommend confirming the proper operation of any circuits or appliances that were off at the time of inspection prior to closing. *If inoperable electrical components (lights, receptacles, appliances, etc.) were mentioned in this report, these breaker(s) being off may or may not be the cause.*

Same breaker, panel cover off

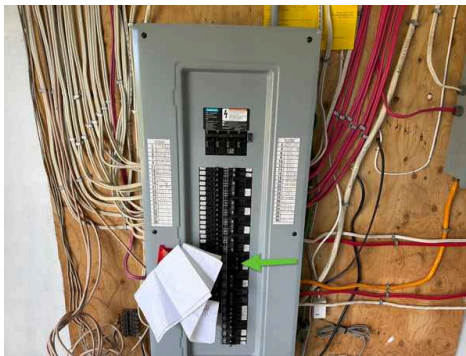
Same breaker, panel cover on

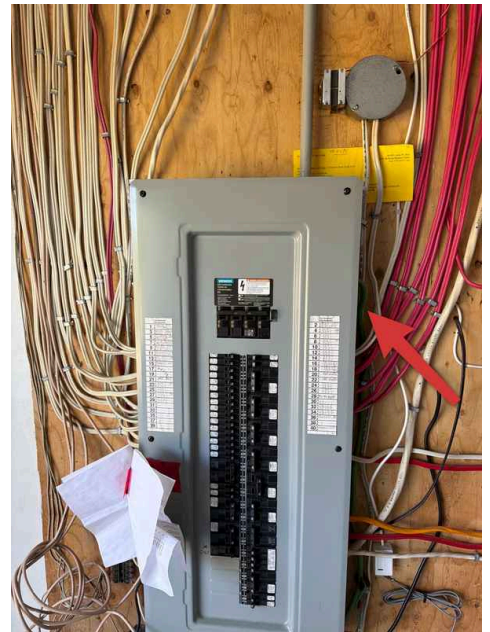
## 14.7.1 Service Grounding/Bonding

**Significant Defects****GEC - CUT**

**SFTY** - The grounding electrode conductor was cut at the referenced area, leaving the electrical system potentially ungrounded. I could not verify the existence of a grounding connection in the panel. An evaluation by a licensed electrician, with repairs if needed, is recommended to confirm grounding system is intact and properly connected.

Contact a qualified electrical contractor.

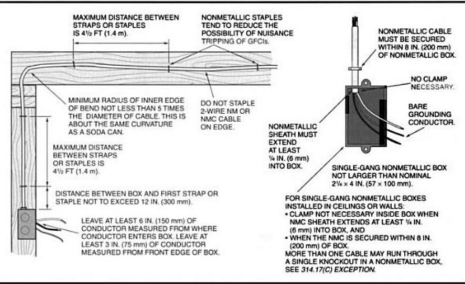
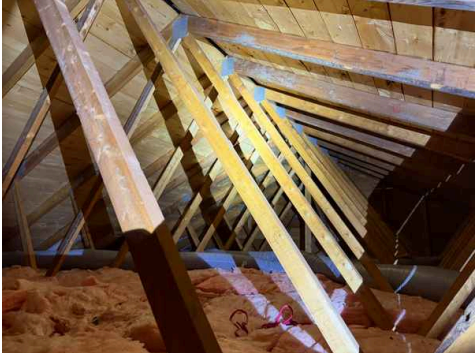
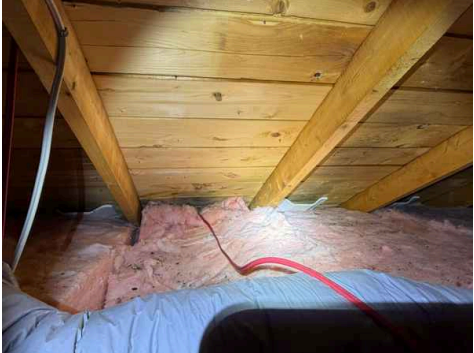
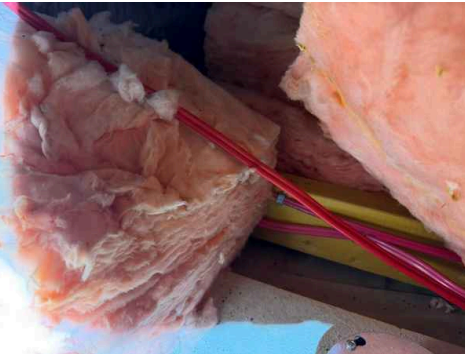
14.8.1 Branch Wiring

WIRING - INADEQUATE/IMPROPER SUPPORT

Wiring was observed that was not properly supported or secured. Electrical conductors should be secured with approved straps or staples within 12 inches of electrical boxes and at intervals not exceeding 4.5 feet. Improper or inadequate support can allow for displacement or physical damage to the wiring. Proper securement of the referenced wiring is recommended to be performed by a licensed electrician.

Contact a qualified electrical contractor.

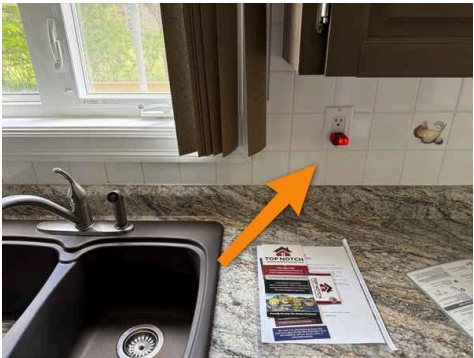
14.10.1 GFCI Protection

GFCI - NOT PRESENT (REPAIR)

**SFTY** - GFCI protection was not present on the receptacle(s) in the referenced area(s). Current standards require it in these areas. The installation of GFCI protection at any areas in need is recommended to be performed by a licensed electrician for safety.

Contact a qualified electrical contractor.

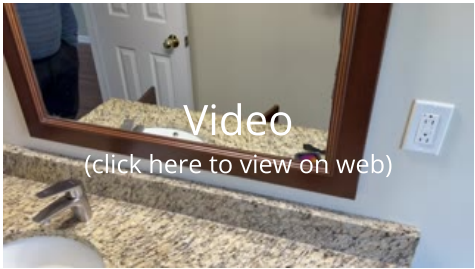
14.10.2 GFCI Protection

GFCI - WOULD NOT RESET

The GFCI receptacle was tripped, by depressing the "test" button to check for proper operation and would not reset, leaving it inoperable. Repairs or replacement of the receptacle as needed is recommended to be performed by a licensed electrician.

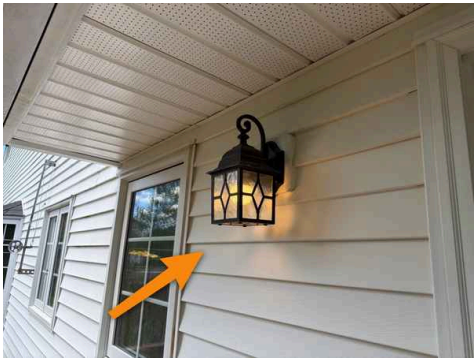
14.15.1 Switches & Light Fixtures

LOOSE LIGHT FIXTURE

A light fixture on the rear exterior of the home was found to be loose during inspection. This loose mounting creates a potential safety hazard, as the fixture could fall and cause injury or property damage. The fixture should be secured by tightening all mounting brackets and fasteners to ensure stable, safe installation.

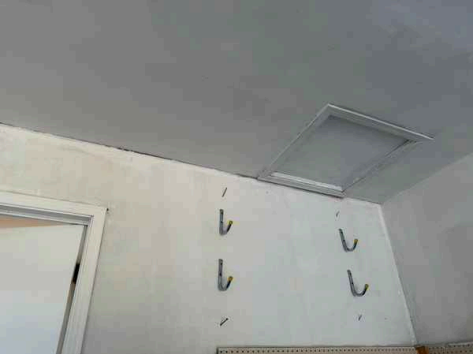
Garage Ceiling

The attic access cover was **not insulated** and/or lacked weatherstripping around the opening. This condition can contribute to energy loss and decreased thermal efficiency. Installing weatherstripping around the opening and affixing a batt of insulation or rigid foam board to the backside of the cover for improved energy performance is recommended to be performed by a qualified person.

Contact a handyman or DIY project

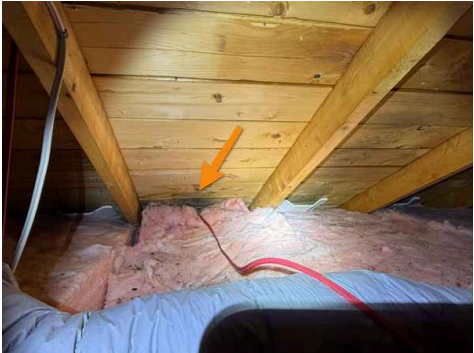
15.5.1 Roof Structure/Framing

Minor discoloration observed at the underside of attic soffit and eave boards near the roof edge during inspection. No active leakage was confirmed at the time of inspection. Discoloration in these areas can indicate moisture exposure or early deterioration, which may lead to water intrusion, structural damage, and fungal growth if left unaddressed. Monitor the affected areas regularly and have a roofing professional evaluate and repair any deteriorated roof-edge materials to prevent future moisture problems. **See comments on shingle age and deterioration.**

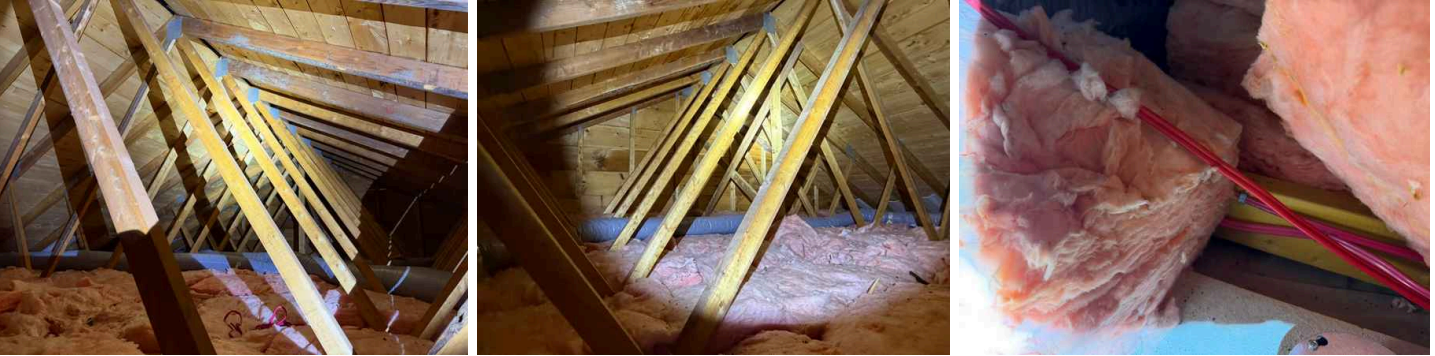
15.6.1 Insulation

INSULATION - ADDITIONAL INSULATION RECOMMENDED

Visible attic insulation appears to be approximately R-38 to R-40, which is below the commonly referenced current target of R-60 for Canadian attic insulation. The installation of additional insulation is recommended to be performed by an insulation contractor to help improve the structure's energy efficiency and comfort.

Contact a qualified insulation contractor.

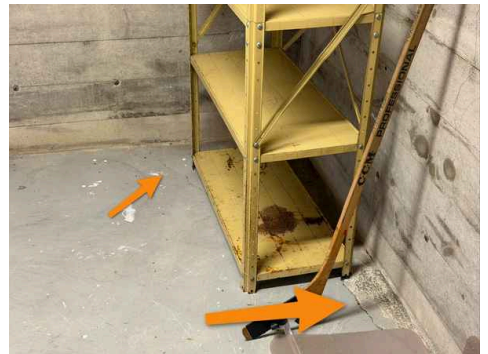
## 16.8.1 Slab Condition

**CONCRETE SLAB CRACK**

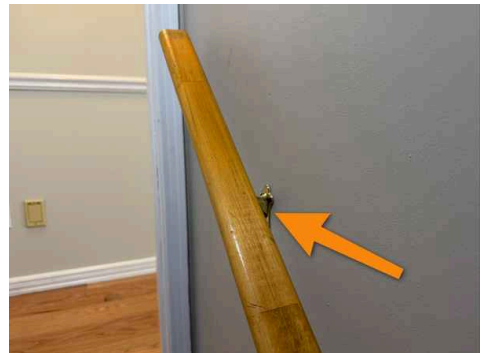
## 16.10.1 Stairs, Rails, &amp; Guards

**HANDRAIL - LOOSE**

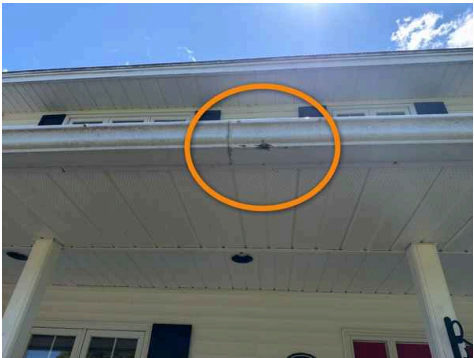
GUTTER LEAK

A hole in the gutter has created a leak located over the front porch roof. While the foundation is not directly affected, water drainage from this leak may impact the porch railing and underlying structure over time. A gutter contractor should inspect and repair the hole to prevent further water damage.

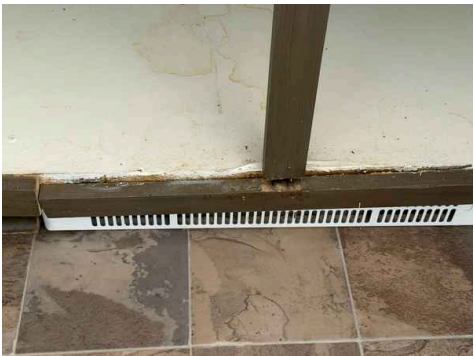
Below kitchen sink

WATER DAMAGE TO CABINETRY

Moderate Concerns

Water damage observed on cabinetry beneath the kitchen sink during inspection. This indicates moisture exposure, likely from the plumbing leak mention previous. Water-damaged cabinetry can lead to structural deterioration, mold growth, and reduced functionality. A plumbing contractor should inspect the sink connections and supply lines, and a cabinet contractor may be needed to assess repair or replacement options.

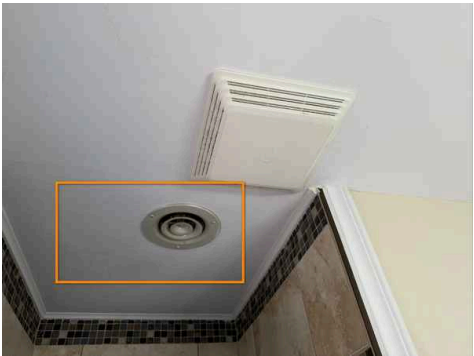
Moderate Concerns

Condensation observed on the shower ceiling in ensuite during inspection. Excessive moisture accumulation can lead to mold growth, material deterioration, and structural damage over time. Improve ventilation by ensuring the exhaust fan operates during and after showers, and consider running it for 20-30 minutes post-shower to remove humid air.

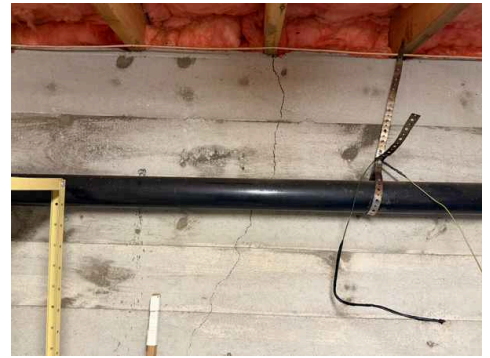
## 18.4.1 Foundation

Walls - CSM

Recommend monitoring.
