TOP NOTCH HOME INSPECTIONS

## RESIDENTIAL PROPERTY INSPECTION

1234 Main Street  
Bay Roberts, NL A0A 1G0

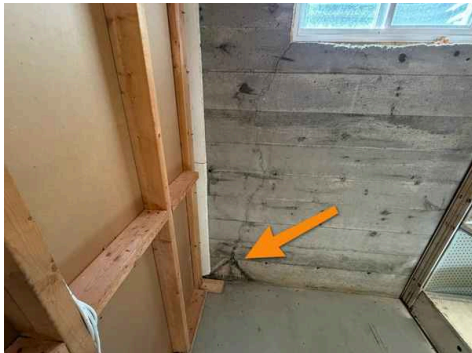
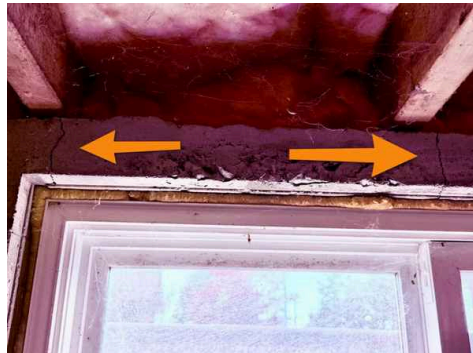
## 18.4.2 Foundation Walls - CSM

**CSM - SIGNIFICANT / NEED EVALUATED**

Contact a qualified professional.

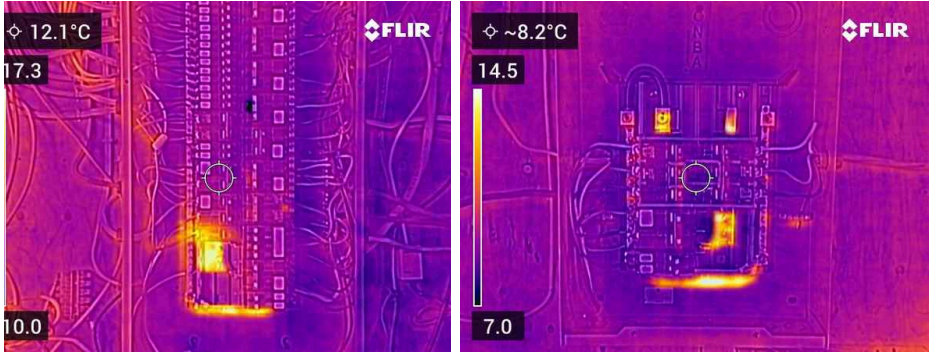
**LMT** - An infrared camera was used to look for thermal anomalies in the electrical panel(s). No anomalies were observed under the current loading conditions at the time of inspection unless otherwise noted in this report.
